Buying and Restoring a Fulvia

By Peter Gerrish and Tim Burrett

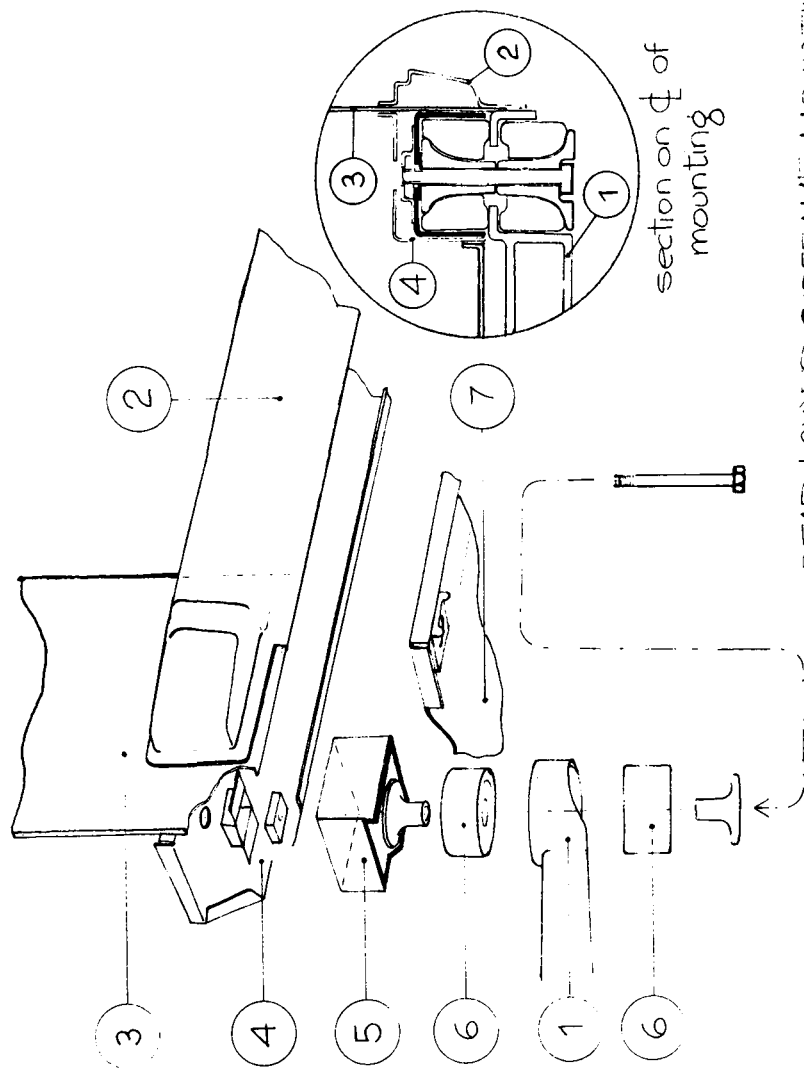
The rigidity of the front end of the car depends much on the subframe (on which the engine, transmission and front suspension are mounted) being in good sound condition. (In the diagrams which accompany this article, the part numbers refer to those mentioned in the text to identify individual parts of the chassis and subframe.) The six mounting points where the subframe is bolted to the chassis must also be in good mechanical order. A useful check on the bending strength of the front end of a Fulvia is to raise it on the jacking point located below the radiator on the front subframe. There should be no significant movement in the rear legs of the subframe (diag. 1.) and little change in the fit of the doors. Try this operation gently on an unknown car and listen carefully for ominous creaks and groans. The subframe itself and the front and top mounting points can be fairly easily inspected and if necessary repaired by welding in substantial steel plates, followed by drilling suitable holes into which Waxoyl or some similar rustproofing is injected. Never weld in new metal to cover up the old; always cut the rusted material away first, otherwise the gap between the two will form an even worse damp and rust trap. There may be complicated shaped corners (such as when reinforcing rear damper top mounts) where this is difficult to achieve. In such a case drill extra holes in the original metal and apply rustproofing copiously after welding.

The outer sill (diag. 2.) runs the full length of the floor pan from the front subframe mount to the front edge of the rear wheel arch and should have an inner sheet steel 'membrane' (diag. 3.) between it and the inner sill (diag. 4.) some 12" long at front and rear. The authors have extended this membrane along the full length of the sill on Fulvias used mainly for competition with a noticeable increase in chassis stiffness. This 'membrane' and the actual box (diag. 5.) in which the subframe mounting rubber blocks (diag. 6.) are located suffer from severe corrosion, and while partially successful repairs have been carried out by welding underneath or by cutting into the inner sill from inside the car, the only guaranteed long term repair in this area is made by cutting into the rear lower part of the front wing and replacing all weakened material with mild steel plate. Complete 10 s.w.g. mild steel mount boxes and full length 18 s.w.g. folded sill sections can be obtained from specialist dealers, or made to order by a 'Yellow Pages' sheet metal fabricator.

The floor sections (diag. 7.) under the inner sills may well be badly corroded and should be plated, preferably along the full length of the floor pan, with 18 s.w.g. steel.
